# 1991 ANNUAL REPORT

## GOVERNMENTS OF CANADA, UNITED STATES, SASKATCHEWAN AND MONTANA

### POPLAR RIVER BILATERAL MONITORING COMMITTEE

COVERING CALENDER YEAR 1991

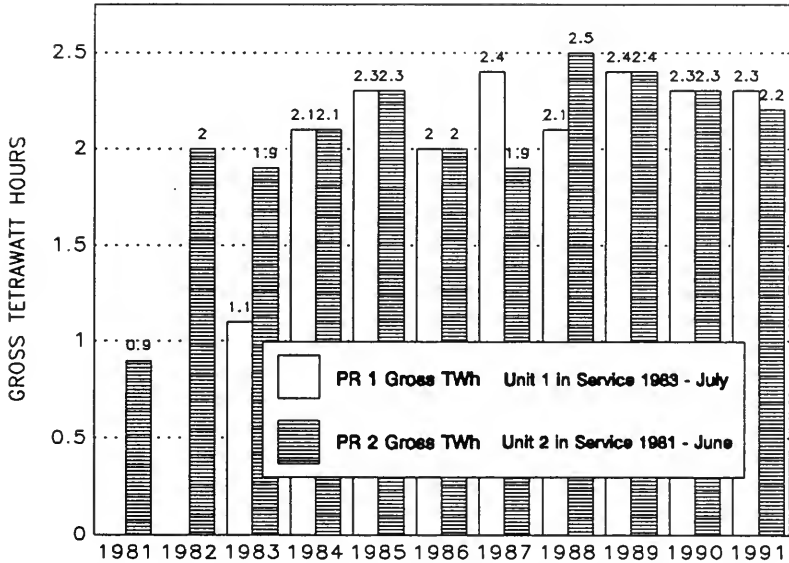
**Figure 2.1 Production History 1981 - 1991, Poplar River Power Station.**

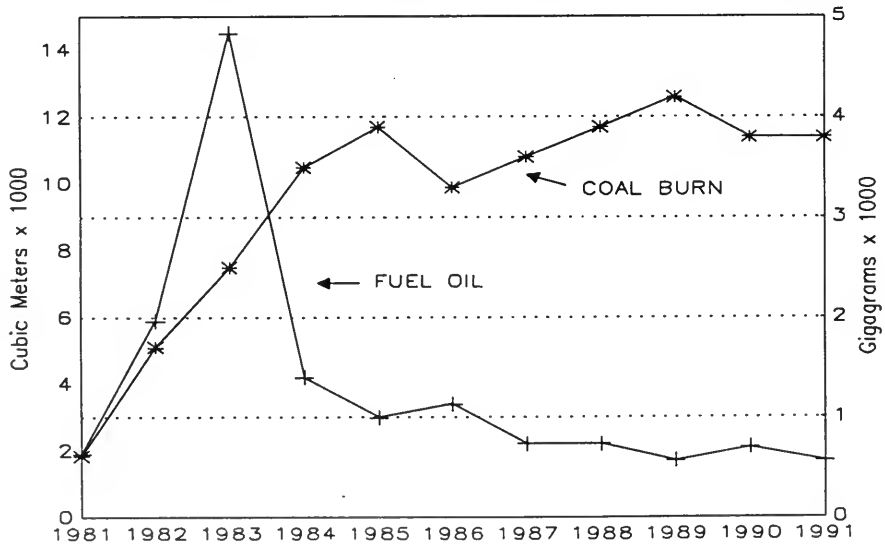
Figure 2.2 Fuel Consumption 1981 - 1991, Poplar River Power Station.

Monthly coal consumption and gross MW/h production is summarized in Table 2.2. Oil consumption is also provided, but monthly values represent both Unit No. 1 and Unit No. 2 consumption. Yearly plant oil and coal usage from 1981 to 1991 are illustrated in Figure 2.2.

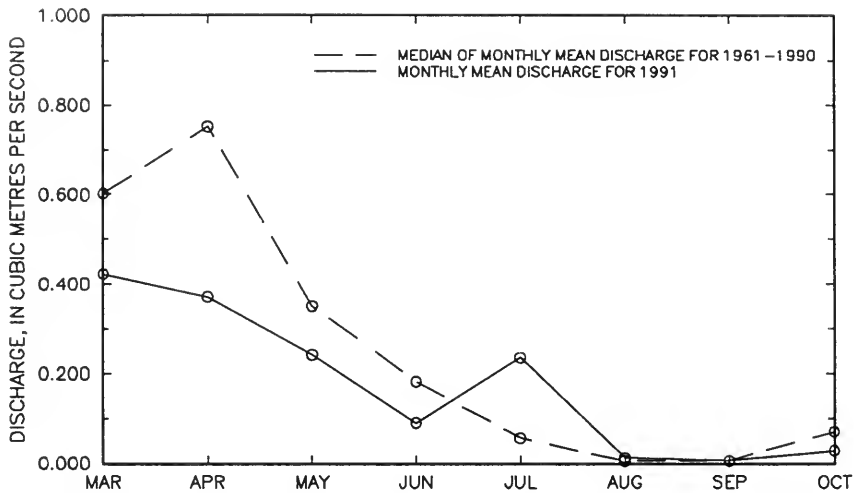
**Figure 3.1 Discharge During 1991 Compared with the Median Discharge for 1961-1990 for the Poplar River at the International Boundary.**

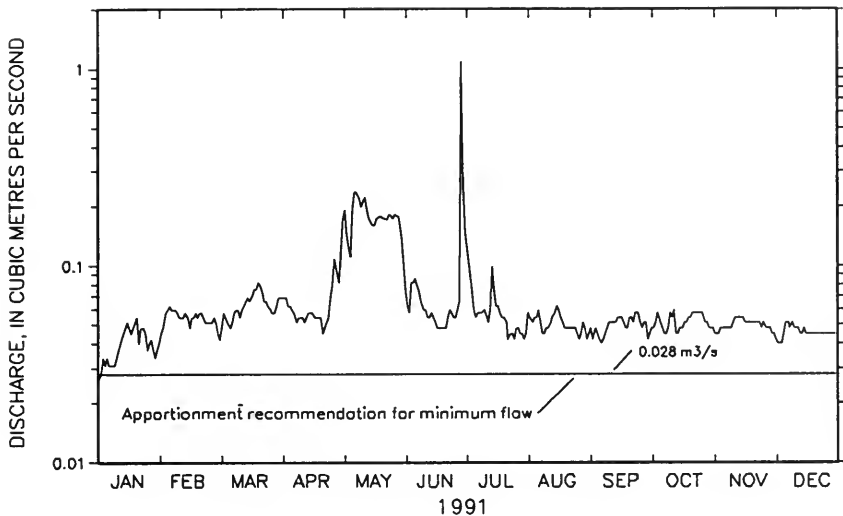
**Figure 3.2 Flow Hydrograph of the East Poplar River at the International Boundary.**

The recorded volume of the Poplar River at the International Boundary from March 1 to May 31, 1991 was 2 740 dam<sup>3</sup>. Based on the IJC recommendations and the assumption that the recorded flow is the natural flow, the United States entitlement is a minimum discharge on the East Poplar River of 0.028 m<sup>3</sup>/s for the period June 1, 1991 to May 31, 1992. The minimum flow for the period January 1 to May 31, 1991 had previously been determined on the basis of the Poplar River flow volume for March 1 to May 31, 1990. A hydrograph of the East Poplar River at the International Boundary and the minimum flow as recommended by the IJC are shown in Figure 3.2. All daily flows during 1991

were above the recommended minimum with the exception of January 1. Icing as a result of extremely cold weather reduced the flow to  $0.026 \text{ m}^3/\text{s}$  on this day.

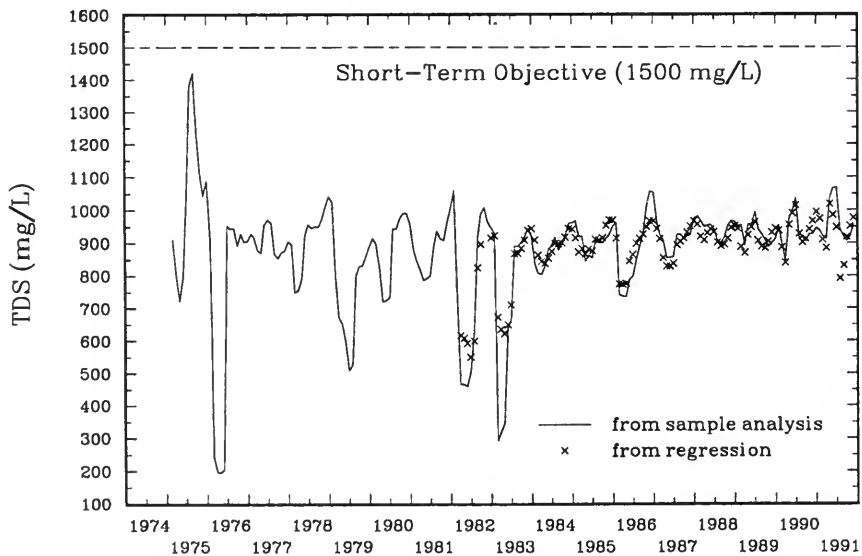
Figure 3.4 Three-Month Moving, Flow-Weighted TDS Concentration for East Poplar River at the International Boundary.

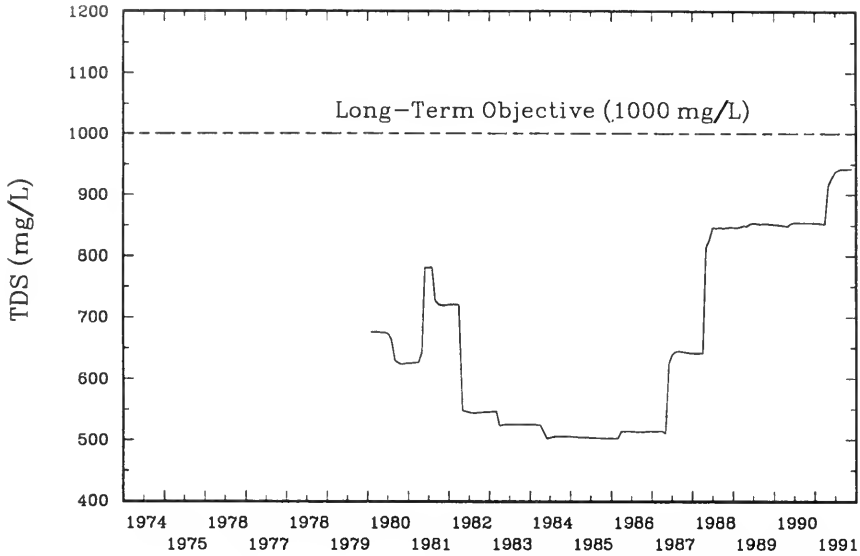
Figure 3.5 Five-Year Moving, Flow-Weighted TDS Concentration for East Poplar River at the International Boundary.

Five-year FWCs for TDS (Figure 3.5) remained below the long-term objective of 1000 mg/L. A 200 mg/L increase in the five-year FWCs which occurred in early 1988 was increased further in 1991 to approximately 950 mg/L. This corresponds to a decline in high spring flows over that period of time. A similar increase in TDS was seen during mid-1987, as a remnant of the 1982 discharge. Relatively low spring discharges have occurred since 1984. If this trend continues, it is expected that FWCs will soon approach the 1000 mg/L objective.

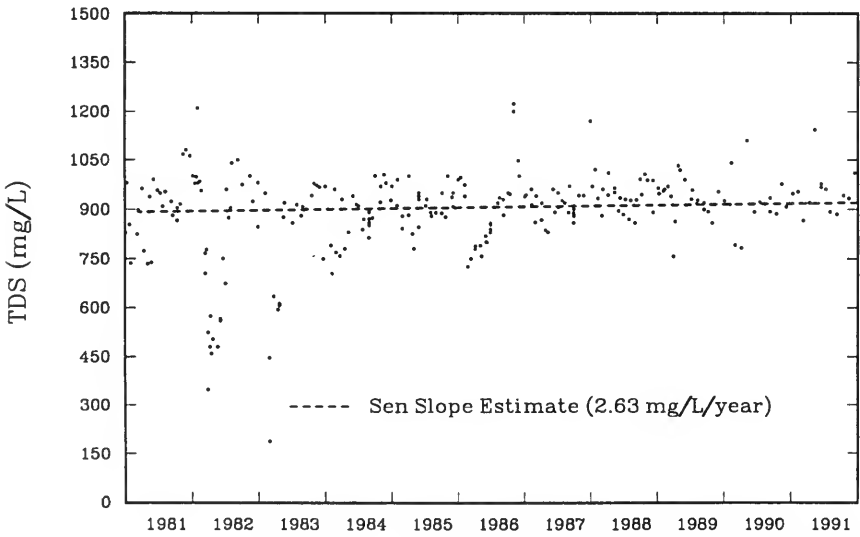
Figure 3.6 Sen Slope Estimate for TDS at East Poplar River at the International Boundary.

Using the Seasonal Kendall Tau test for trend assessment, TDS showed a statistically significant increase from 1981 to 1991 (90% confidence level). The Seasonal Kendall Sen Slope estimates the approximate TDS increase to be 2.63 mg/L/year (Figure 3.6). This positive trend could be explained by the drought conditions that occurred over the later half of the data record. The TDS increase comes from salt buildup in the reservoir as a result of water being used for cooling. High evaporation of this water (as a result of drought conditions) causes salts to remain within the reservoir. In addition, low flow conditions (when flows are derived largely from groundwater sources) likely increase TDS concentrations and yields a positive TDS trend in the data.

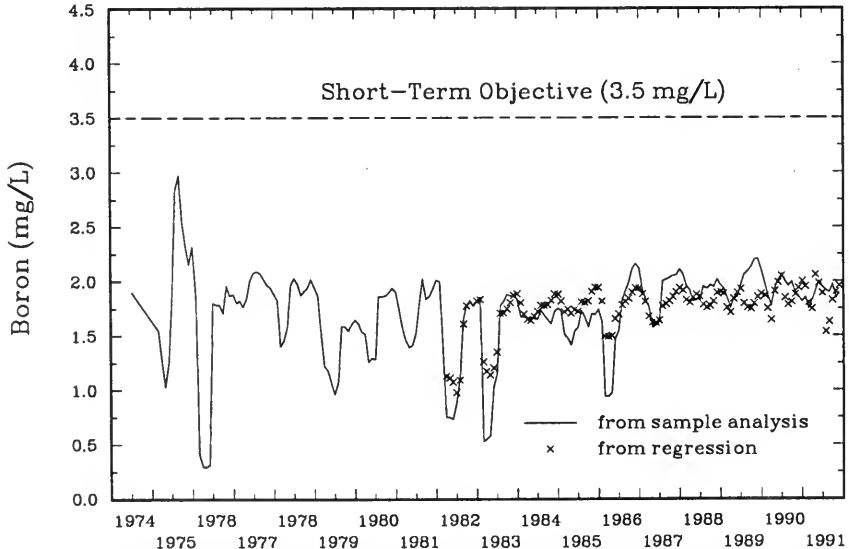
Figure 3.8 Three-Month Moving, Flow-Weighted Boron Concentration for East Poplar River at the International Boundary.

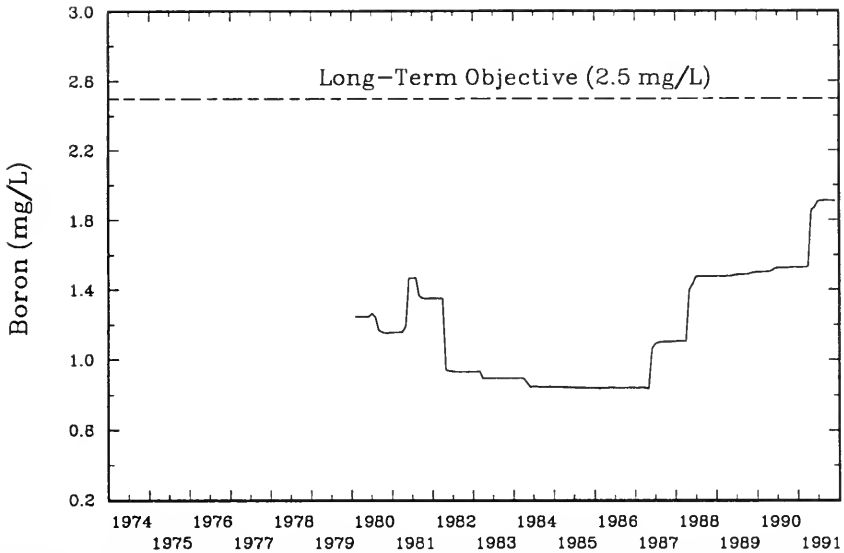
**Figure 3.9** Five-Year Moving, Flow Weighted Boron Concentration for East Poplar River at the International Boundary.

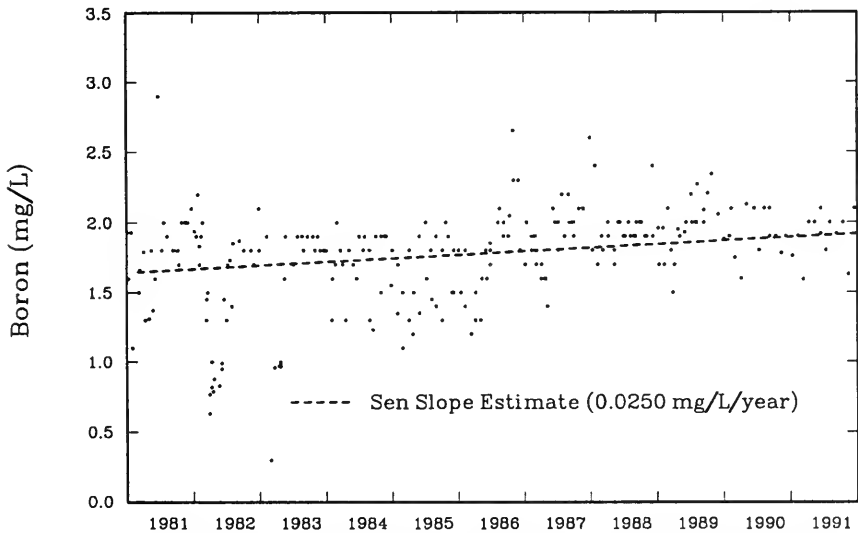
**Figure 3.10** Sen Slope Estimate for Boron at East Poplar River at the International Boundary.

As shown in Figure 3.10, boron levels undergo a statistically significant increase from

1981 to 1991 (90% confidence level). The boron increase, as calculated by the Seasonal Kendall Sen Slope Estimate, is approximately 0.0250 mg/L/year. As with TDS, this trend may be explained by the drought conditions in addition to consumptive use of water for cooling and natural evaporation from Cookson Reservoir.

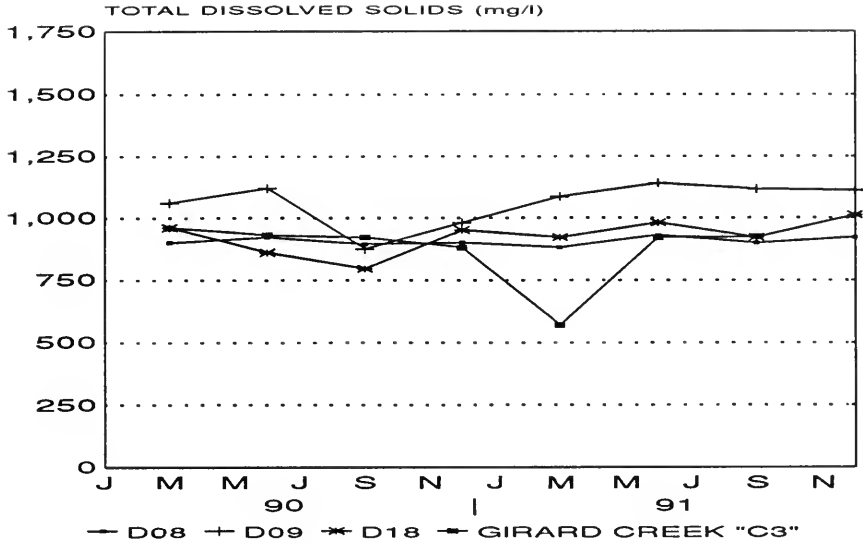
Figure 4.3 TDS for Selected Discharge Points, 1990 and 1991.

Included in Figures 4.3 and 4.4 are the results from Girard Creek Location "C". This location is directly downstream from the majority of pumpwells and provides a good indication of water quality going to the reservoir. Water quality at "C" is much better than the reservoir quality and therefore this water has a positive influence on the reservoir water quality.

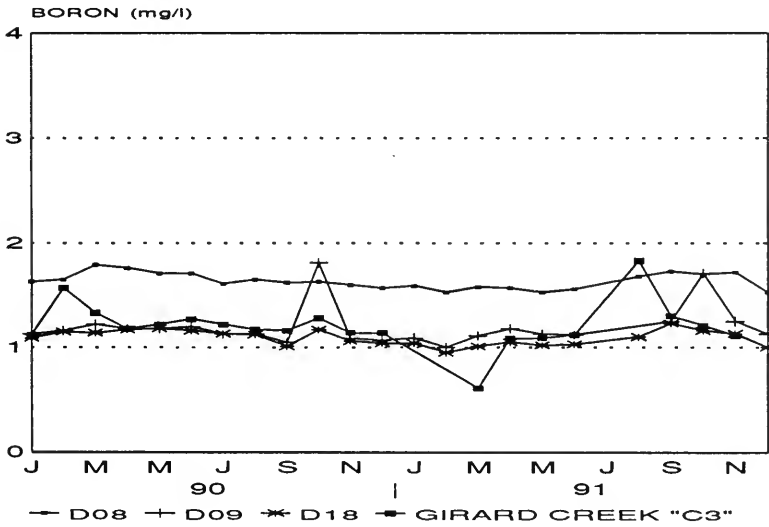
Figure 4.4 Boron for Selected Discharge Points, 1990 and 1991.

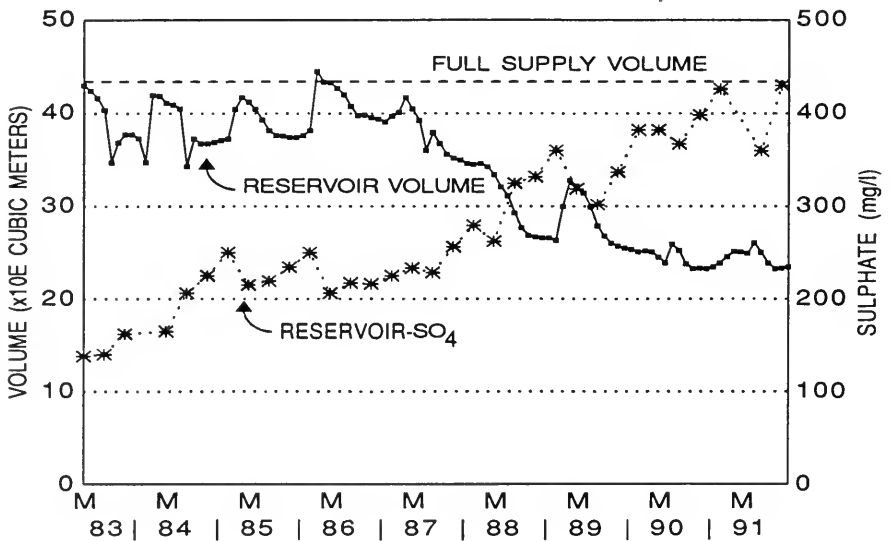
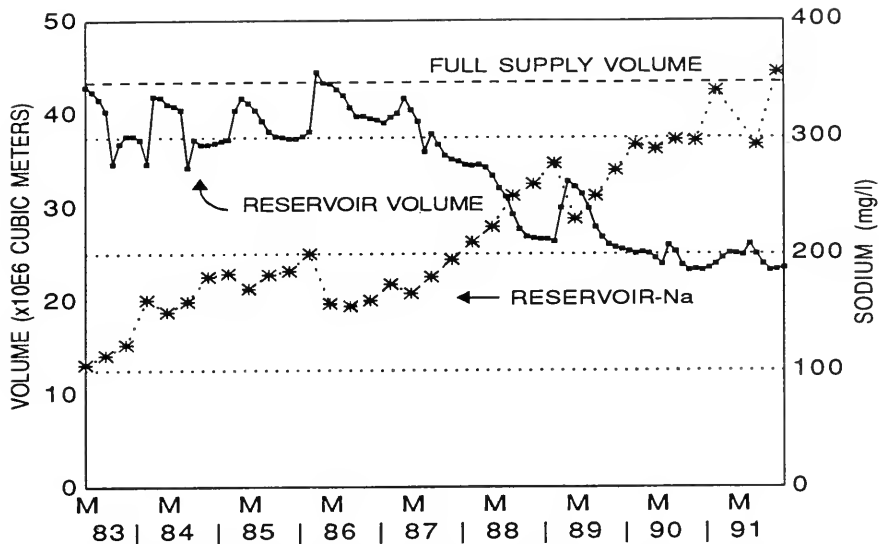
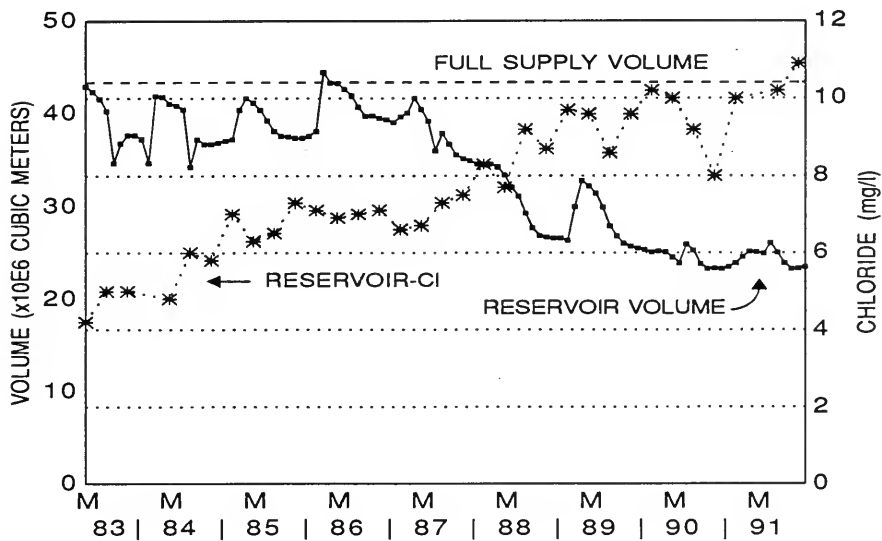
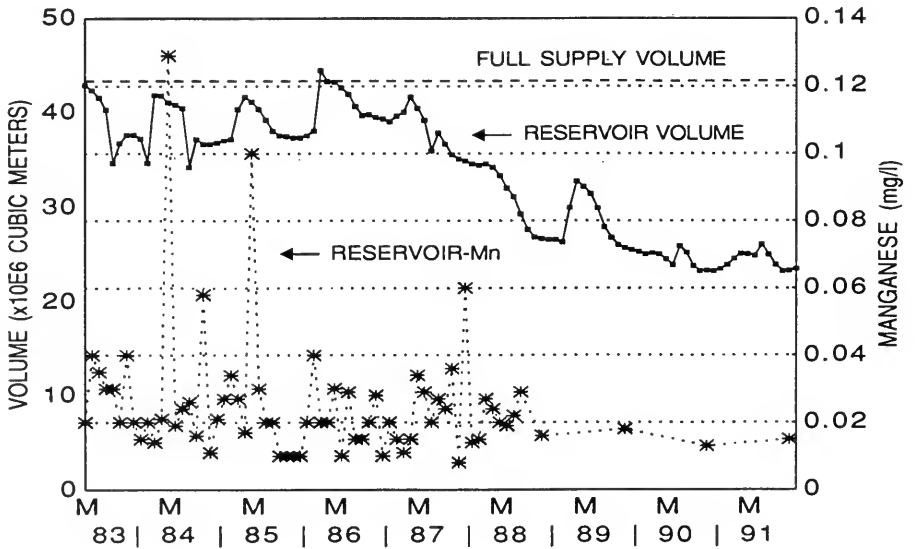
Figure 6.2 Cookson Reservoir Water Quality Data for Boron, 1983 to 1991.

Figure 6.3 Cookson Reservoir Water Quality Data for Sulphate, 1983 to 1991.

Figure 6.4 Cookson Reservoir Water Quality Data for Sodium, 1983 to 1991.

Figure 6.5 Cookson Reservoir Water Quality Data for Chloride, 1983 to 1991.

Figure 6.6 Cookson Reservoir Water Quality Data for TDS, 1983 to 1991.

Figure 6.7 Cookson Reservoir Water Quality Data for Manganese, 1983 to 1991.

The net effect of little spring runoff over the last several years has been a decrease in reservoir water quality. Figures 6.2 to 6.8 show the decreasing water volume of the reservoir and the increasing concentration of boron, sulphate, sodium, chloride, TDS, manganese, and strontium. The deterioration in water quality will continue unless there is an above average runoff in the spring of 1992.

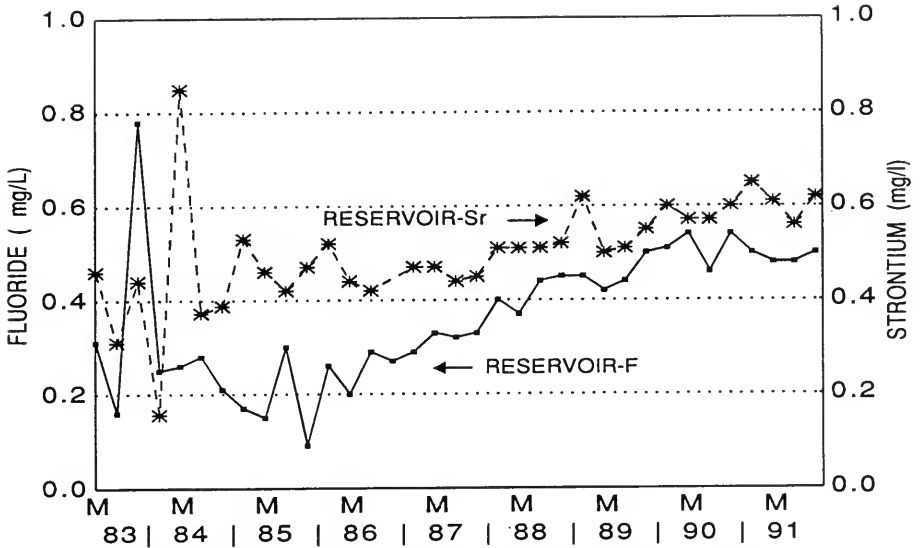
**Figure 6.8 Cookson Reservoir Water Quality Data for Strontium and Fluoride, 1983 to 1991.**

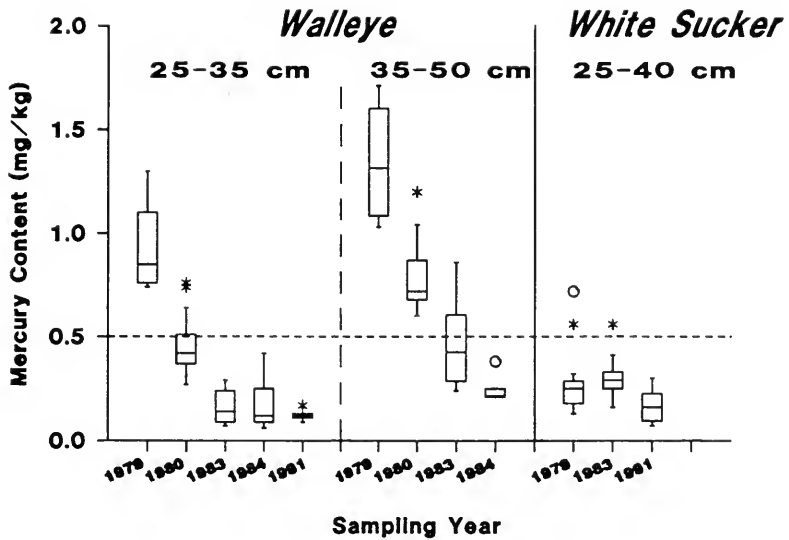
Figure 6.9 Box and Whisker Plots of Tissue Mercury Concentrations in Fish from Cookson Reservoir from 1979 to 1991. Data from Water Quality Branch (1980), Waite *et al.* (1980), Munro (1985) and Shaw (1991, in prep). Dashed horizontal indicates current Health and Welfare Canada consumption guideline of 0.5 mg/Kg Hg.

Mercury concentrations in edible tissue of two size-classes of walleye (Stizostedion vitreum) from 1979 to 1991 (Figure 6.9) followed the expected pattern. Mercury burden in edible tissue of smaller classes of walleye (25-35 cm) declined rapidly from a median concentration of 0.85 mg/Kg in 1979 to 0.29 mg/Kg in 1983. Likewise, the mercury concentration in larger fish (35-50 cm), while remaining higher than in the smaller fish, declined from 1.32 mg/Kg in 1979 to 0.42 mg/Kg in 1984. Mercury concentration of white suckers (Catostomus commersoni) from Cookson reservoir was low (median 0.25-0.29 mg/Kg Hg) and showed a slight but significant decline from 1979 to 1991 (Kruskal-Wallis 2-sample test,  $p=0.61$ ).

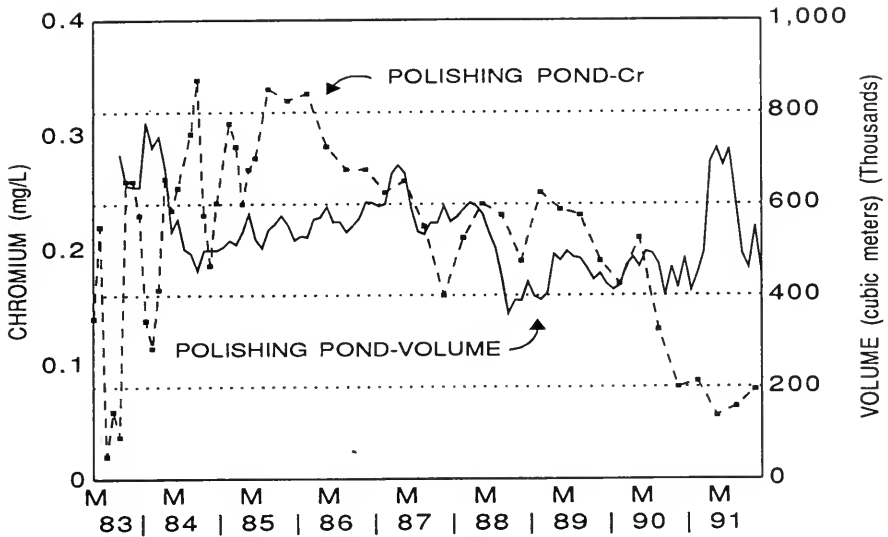
Figure 7.4 Lagoon Water Quality Data for Chromium and Polishing Pond Volume, 1983 to 1991.

The levels of both vanadium and chromium have been in the 0.1 to 0.4 mg/L range. During the winter of 1990/91, test results for both parameters decreased sharply below 0.1 mg/L but have since increased to near previous levels. From 1984 to 1988, a modest increasing trend was noted for molybdenum with steady values of between 3.0 and 4.0 mg/L for 1988 to 1990. From late 1990 to mid-1991, values were declining but by the end of 1991 molybdenum results had returned to pre-1990 levels.

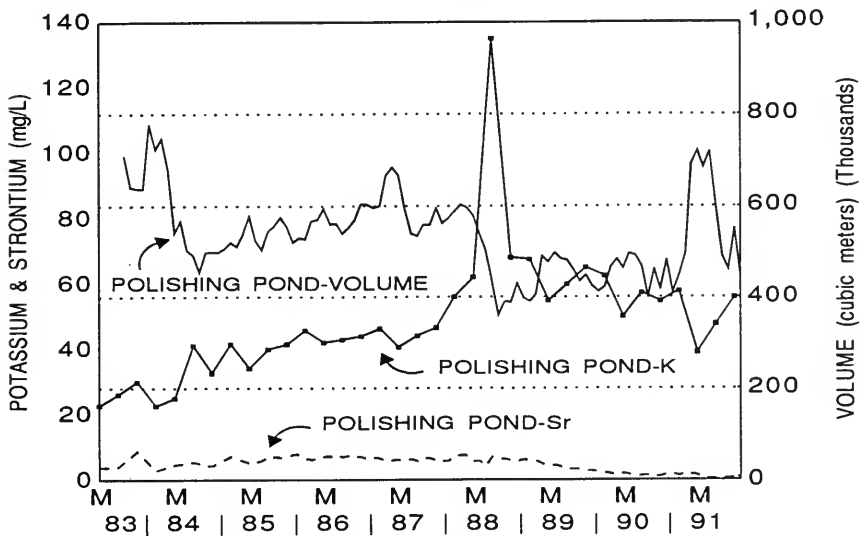
Figure 7.7 Lagoon Water Quality Data for Potassium, Strontium and Polishing Pond Volume, 1983 to 1991.

As shown in Figure 7.7, potassium results were increasing from 1983 to 1988. A large spike of 135 mg/L was observed in August 1988, followed by steady results of about 60 mg/L to 1990. Like other test results, potassium levels dropped in early 1991 and by the end of the year had increased to previous levels.

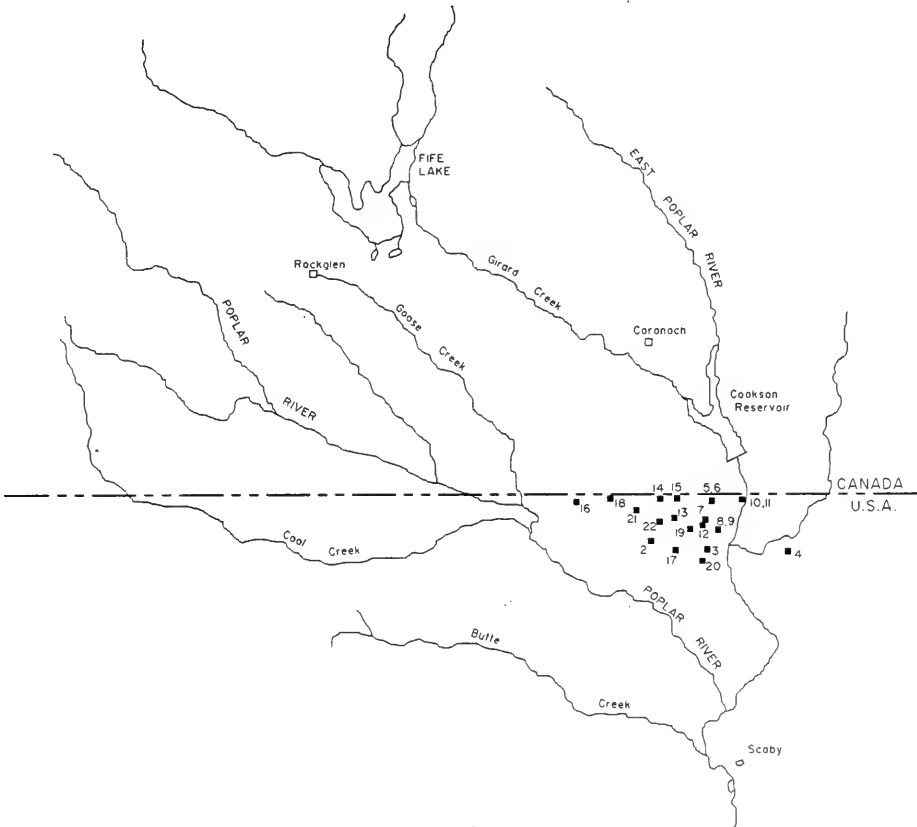
GROUND WATER QUALITY MONITORING (UNITED STATES)

**GROUND WATER LEVELS TO MONITOR POTENTIAL  
DRAWDOWN DUE TO COAL SEAM DEWATERING**
